# PHILCO SERVICE

## PHILCO RADIO, MODEL 46-1201

### PRODUCTION CHANGES FROM APRIL 1, THROUGH AUGUST 31, 1946

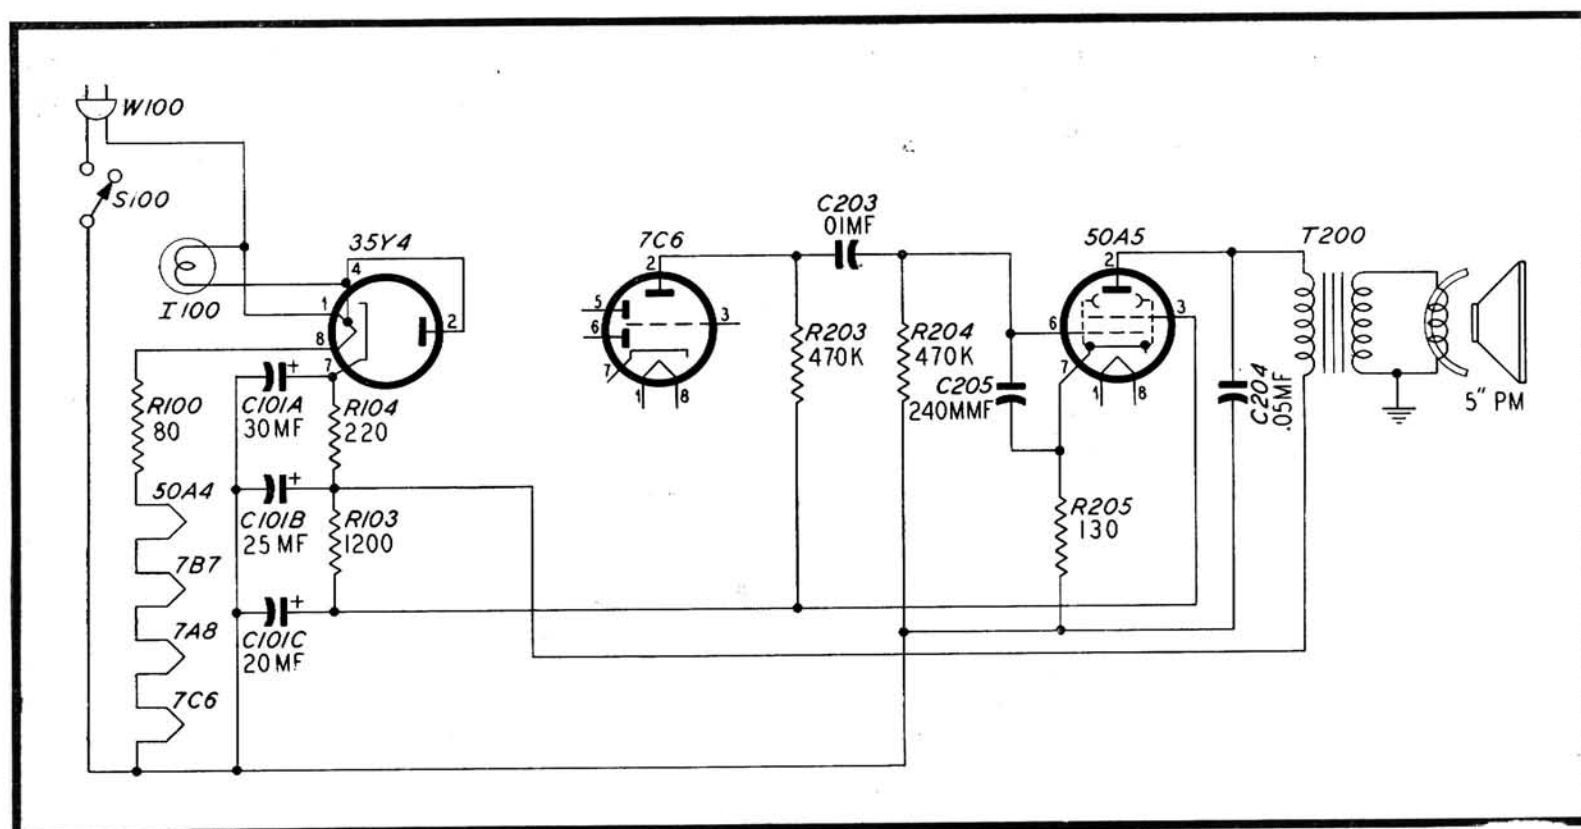
FIGURE 1. POWER SUPPLY AND AUDIO SECTION USED ONLY IN CODE 122.

Code 122 of the Model 46-1201 is different from all other 46-1201 codes because the voltage-doubler power-supply circuit was removed and replaced with a conventional half-wave rectifier circuit. The 4" x 6" oval electrodynamic speaker was replaced with a 5" round, permanent-magnet speaker. Because of the removal of the speaker field as a choke, considerable changes were made in the power-supply filter network. Parts changes and schematic (figure 1) applicable to Code 122 are as follows:

1. Tube, rectifier, 50Y6GT/G, was changed to a 35Y4.
2. Tube, audio output, 35L6GT/G, was changed to a 50A5.
3. Condenser, C101, part no. 30-2559; C102, part no. 30-2559; and C104, part no. 30-2548, were replaced by a triple section 30-25-20 mf condenser, C101A, B, C, part no. 30-2573. Part of manual affected: Replacement Parts List and figures 3 and 12.
4. Speaker, electrodynamic, oval, part no. 36-1587\*, was replaced with a round 5" permanent-magnet speaker, part no. 36-1617-2. Part of manual affected: Replacement Parts List and figures 5 and 12.
5. Cable, speaker, 41-3728, was changed to 41-3759. Part of manual affected: Replacement Parts List.
6. Resistor, R100, dual, 80 ohms, 65 ohms, part no. 33-3426, was replaced by single 80-ohm resistor, part no. 33-3425.

7. Resistors, R101 and R102, were removed from power-supply filter circuit. Part of manual affected: Replacement Parts List and figures 3 and 12.
8. Condenser, C103, was removed. Part of manual affected: Replacement Parts List and figures 3 and 12.
9. Condenser, C204, .03 mf, part no. 45-3500-1\*, was changed to a .05 mf, part no. 61-0122\*. Part of manual affected: Replacement Parts List and figures 5 and 12.
10. Resistors, R103, 220 ohms, part no. 66-1224340\*, and R104, 1200 ohms, part no. 66-2123340\*, were added to power-supply filter circuit. Part of manual affected: Replacement Parts List and figures 3 and 12.

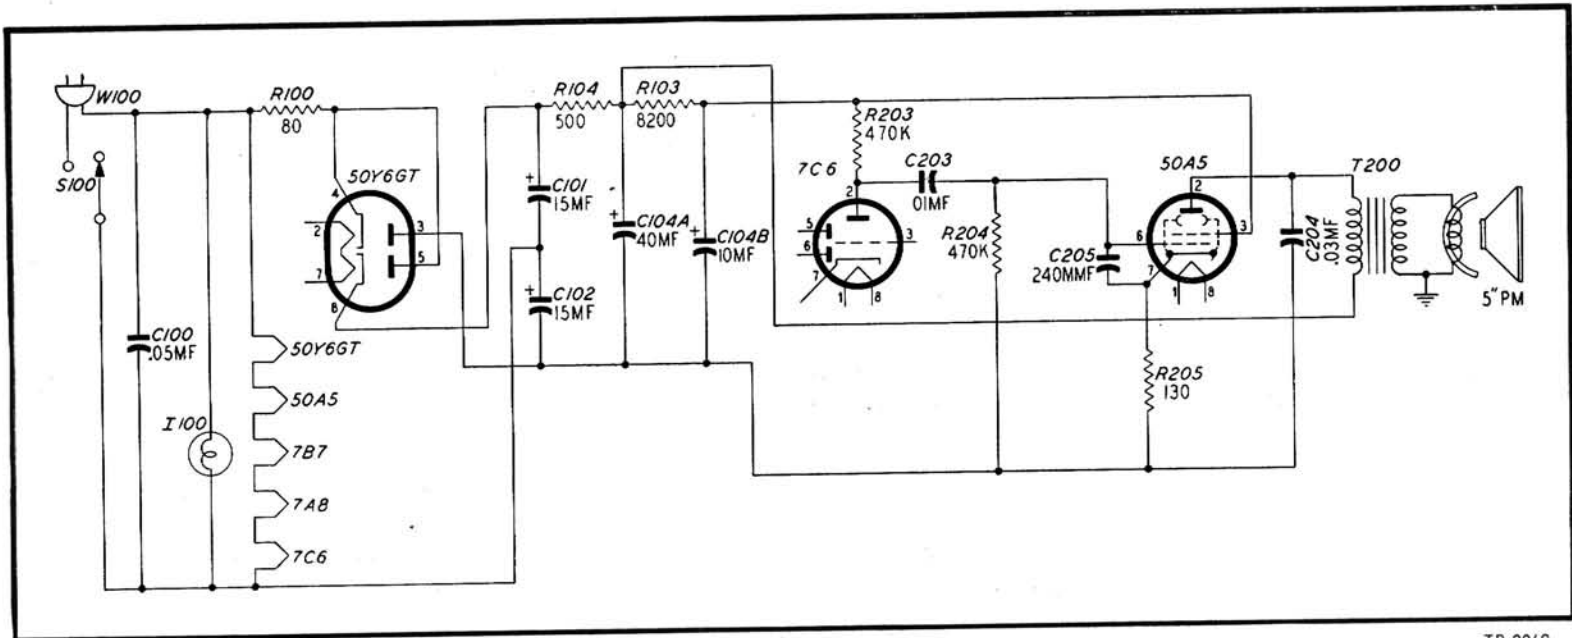
FIGURE 2. POWER SUPPLY AND AUDIO SECTION USED IN CODE 127.

18. Code 127 is similar to Code 121 (as shown in manual) except that it uses a permanent-magnet dynamic speaker and a Loktal type 50A5 output tube in place of a 35L6GT/G. The rectifier filter circuit was changed to use a resistor in place of a filter choke. Parts changes and schematic (figure 2) applicable to Code 127 are as follows:

19. Tube, audio output, 35L6GT/G, was changed to a 50A5.
20. Resistor, R205, 130 ohms, part no. 66-123340\*, was added to cathode of 50A5. Part of manual affected: Replacement Parts List and figures 5 and 12.

21. Resistors, R104, 500 ohms, part no. 33-3435-3, and R103, 8200 ohms, part no. 66-2824340\*, were added to power-supply filter circuit. Part of manual affected: Replacement Parts List and figures 3 and 12.

22. Speaker, electrodynamic, oval, part no. 36-1587\*, was replaced with a round 5" permanent-magnet speaker, part no. 36-1617-2. Part of manual affected: Replacement Parts List and figures 5 and 12.

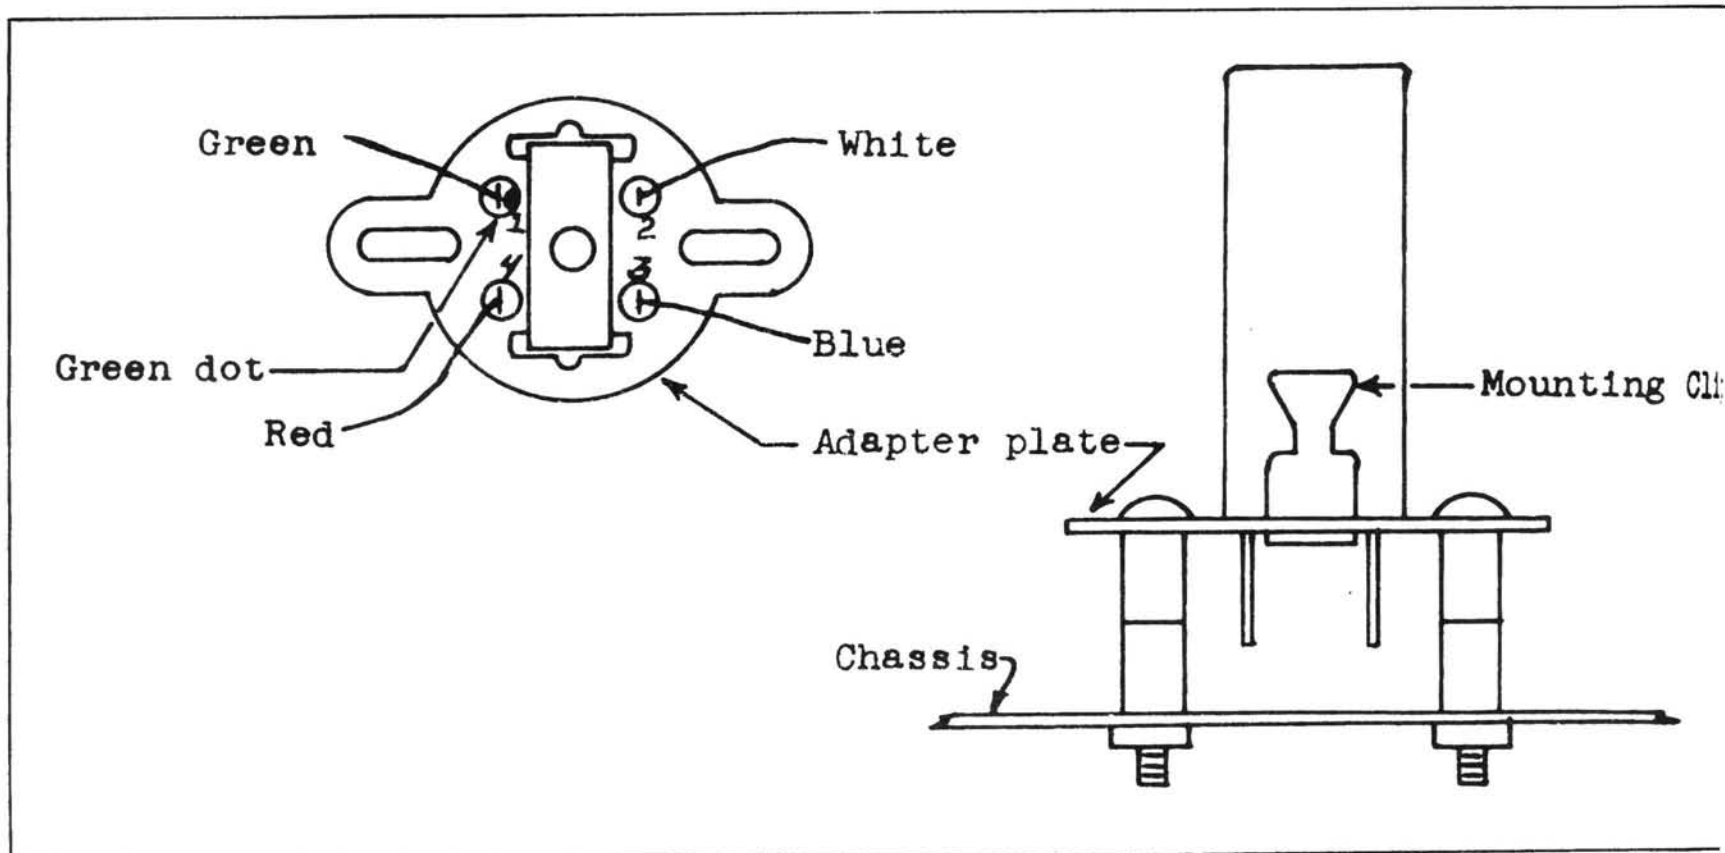
The majority of these cases have been traced to a change in tuning of the second i-f transformer, Z301, Part No. 32-4005. This transformer, because of its location close to the output tube, becomes overheated under certain operating conditions, causing wax to flow from the coil or coil form into the trimmer-condenser plates. Therefore, detuning of the stage and loss of sensitivity and selectivity result.

Since the trimmer plates become stuck together, retuning of the stage is often difficult, and even if accomplished, subsequent heating and cooling may again result in detuning. A permanent repair may be made by replacing the faulty transformer with one of the permeability-tuned type. A kit, Part No. AD-1024, includes this transformer and mounting hardware.

1. Remove the two nuts used to mount the original coil, 32-4005.
2. Force one end of the brass coil-retaining clip upward and inward, to permit the coil shield can to be removed.
3. Cut the red, blue, white, and green leads, leaving one inch in length above the chassis, and strip one-half inch. Cut the black lead off close to its terminal under the chassis, as this lead is not used.

4. Drill a 3/16-inch hole halfway between, and in line with, the two holes in which the transformer was mounted; this provides an access hole for the transformer primary adjustment. Some codes have a hole that may be used for this purpose by mounting the replacement transformer at a suitable angle to use holes available.
5. Set the new transformer in place, with terminals 1 and 2 adjacent to the rectifier tube, and make the connections as shown in the bottom-view drawing.

6. Install the transformer in the mounting holes for the original transformer, by means of the adapter plate and hardware provided, as shown in the side-view drawing.
